- 12.6 ps Risetime
- 40 GBit/s
- Z-matched
- No Reflection

The PSPL model 5935 Low-Pass Risetime Filters are designed for OEM use in high speed digital networks and telecom systems. The devices use a proprietary, absorptive filter design that has attenuation and group delay frequency responses similar to those of the 4th order **Bessel-Thomson** filter. Traditional Bessel-Thomson designs filter by reflecting stop-band frequency signals and thus can cause increased bit error rates and eye diagram closure due to multiple reflections. By contrast, the PSPL filters filter by *absorption*. They have excellent impedance matches and very good return losses, both within and above the filter pass band.

1.85MM CONNECTOR ADDENDUM

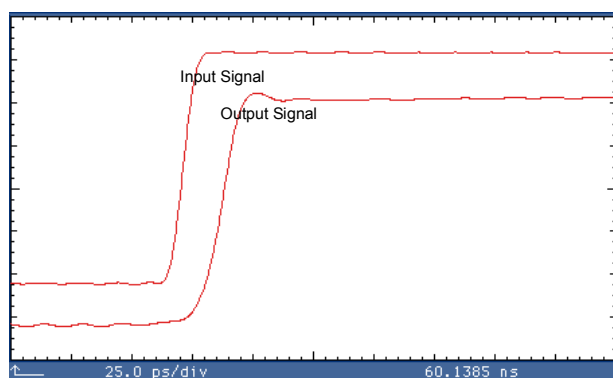
TDT Response to 10 ps step. Timebase 20 ps/div. Measured with PSPL 4015C Pulse Generator & HP54750, 50 GHz Oscilloscope. See AN-5c for details.

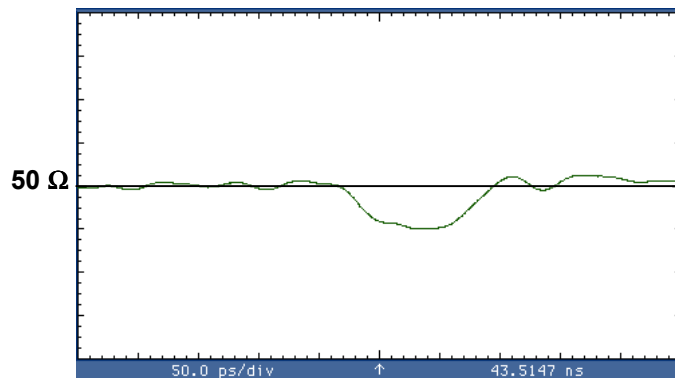
TDR of 5935 Filter using 25 ps step. Scale 5% p/div, 50 ps/div.

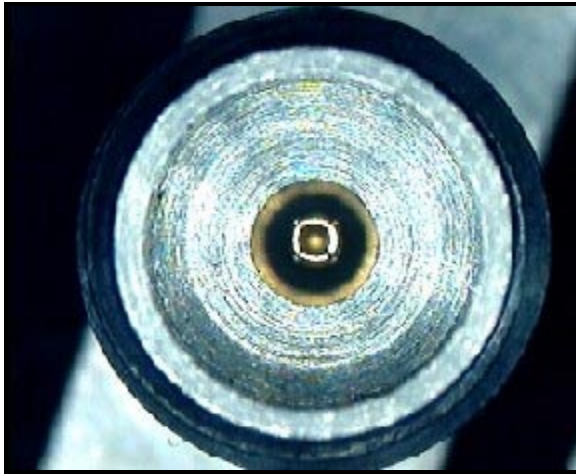
Figure 2. New Female Connector

Allowing the body of the component to rotate during the assembly or disassembly process can break the center pin captivation or cause wear on the surface of the mating shoulders that form the outer conductor connection that is the ground contact. The surface wear appears as abrasion or galling of the metal surfaces that can cause an air-gap or poor ground contact, either of which create an impedance mismatch that may result in poor microwave performance. EVEN SLIGHT WEAR THAT MAY ONLY BE VISIBLE UNDER A MICROSCOPE CAN HAVE A SIGNIFICANT NEGATIVE IMPACT ON THE PERFORMANCE OF THE CONNECTOR. The photos in Figures 3 and 5 show the damage caused to the ground interface due to improper assembly and disassembly of the 1.85mm Female (Jack) and Male (Plug) connectors, respectively.

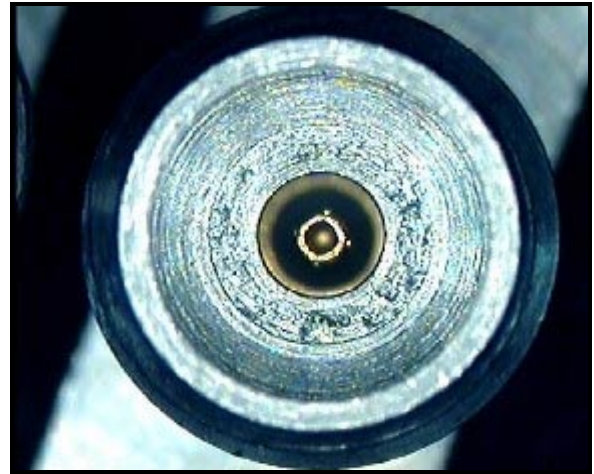
Figure 3. Damaged Female Connector

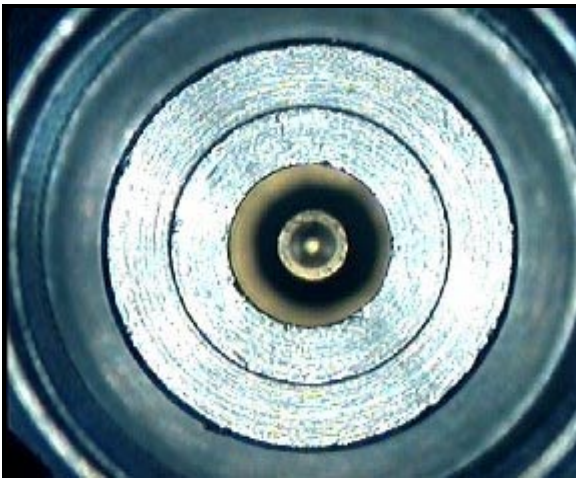
Figure 4. New Male Connector

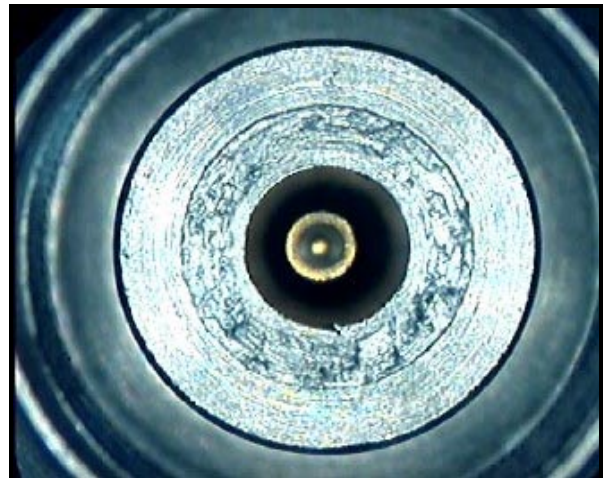
Figure 5. Damaged Male Connector
